Chapter 1:

Challenges and Solutions in the Architectural Conservation of 'Zamindar Houses': Insight from Chattogram, Bangladesh

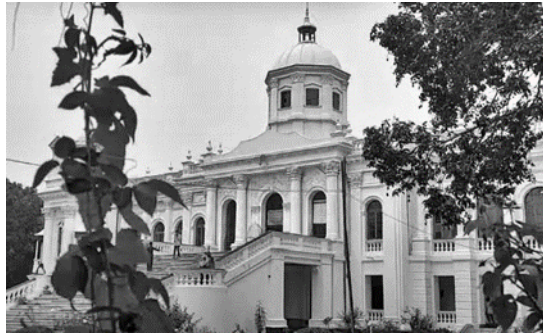
Figure 4. Tajhat Palace (Source: Author).

Popular by the name Tajhat Palace or Rajbari, the Zamindar residence of jeweler Kumar Gopal Lal Roy was built at the beginning of the 20th century. Standing in the south of Rangpur City, the house exemplifies neoclassical architecture (Ahmed & Kabir, 2010). The palace's layout takes the form of a U-shape and contains 22 apartments distributed over two levels (Ahmed, 1986). Two water reservoirs, a backyard court, a water spring in the frontcourt, flower gardens, and trees altogether create a pleasant landscape. With a fusion of traditional Bengali, North Indian and European architectural design, the house forms a distinguished style regarded as Racial Classism (Ahmed & Kabir, 2010). Representing 20th-century occidental architecture, the palace displays a grand staircase, raised platform, symmetrical wings, an octagonal dome, Corinthian columns, and ornate semicircular arches (Kabir, 2009).

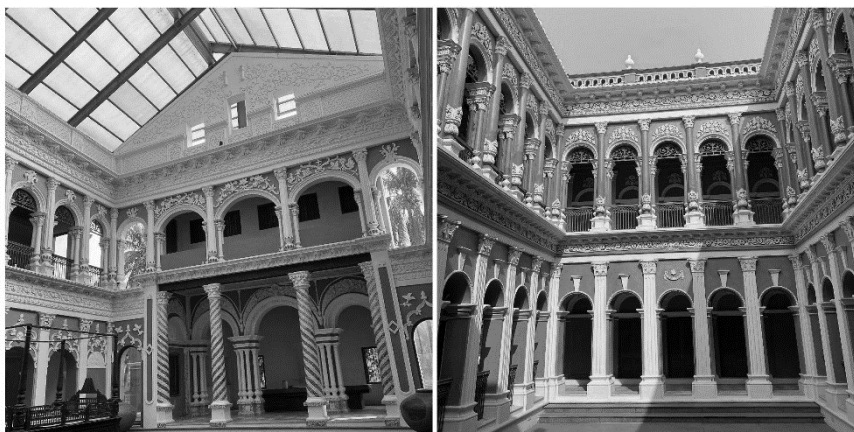
Figure 5. Baro Sardar Bari (Source: Author).

The historic Baro Sardar Bari in Sonargaon stands as a unique example of the restoration of heritage buildings in Bangladesh. According to the inscription on the entry wall, the construction of the house dates back to the early Mughal period. The residential complex was constructed in 1892 with an addition in 1902 by a wealthy Bengali Zamindar (Lee, 2021; Bari, 2021). An addition of a verandah, a front courtyard, and a new entrance occur during that period. The new entrance was designed using a traditional ornamentation technique known as "Chinni Tikri" or China mosaic (Adnan, 2021). According to the locals, the house was once comprised of a treasury, courtroom, Thakur Ghar (pray zone), dance hall, bathing zone, and secret passageway. The vast complex displays a remarkable example of colonial architecture covering over 27000 square feet and more than 80 rooms (Mohsin, 2018).

independence. The restoration of the house to its original state was the goal of a public-private partnership formed in 2012. In total 150 experienced and skillful masons from Naogaon and Paharpur were appointed to restore the original beauty of the house (Bari, 2021). According to the conservation architect, the process included documentation and preparation of detailed drawings of the façade and ornamentation, reconstruction of the inner courtyard, and plastering of interior walls (Ahmed, 2018). As stated by him, the lack of available published literature on its social history made the process challenging. To safeguard the evidence from the Mughal to Colonial period and its complex history, the majority of the building underwent restoration. This entailed employing new techniques and materials for structural stability, such as replacing the stained glass with broken bottles in the columns and swapping cast iron railings with aluminum railings. As of 2018, the house remains a top tourist destination serving as the Folk Art Museum of Bangladesh.

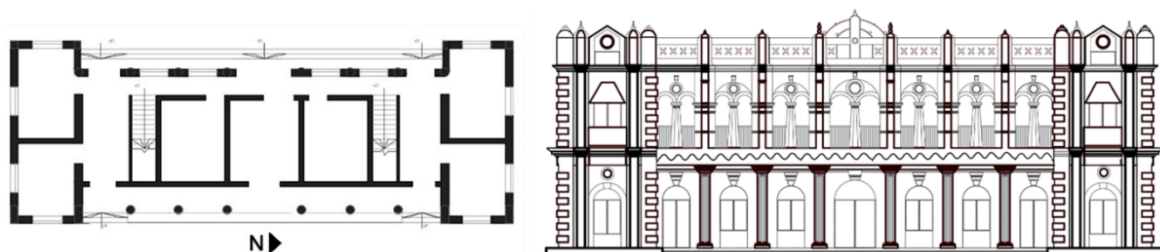
Figure 7. Ground Floor Plan of Andarmahal (left) and Andarmahal Elevation (right) (Source: Author).

The Zamindar house stands as a significant example of the brick architecture of the early 20th century. The structure with little-known history has not been documented to date. As stated by local people, the area was the center of most activities for the peasants and communities of Chikondondi and Dakshin Pahartali. The war resulted in armed robbers looting the mansion of ornamental and expensive parts worth over Taka 3 Crore. The landlord's family moved to Kolkata to safeguard themselves from the Pakistani army's assault, where 'Radio Akashvani' broadcasted songs of freedom performed by the landlord's sons. The Kachari House and Durga Temple were burned. The family returned a few months after the country's independence, and presently the house is inhabited by the Zamindar's grandsons and granddaughters.

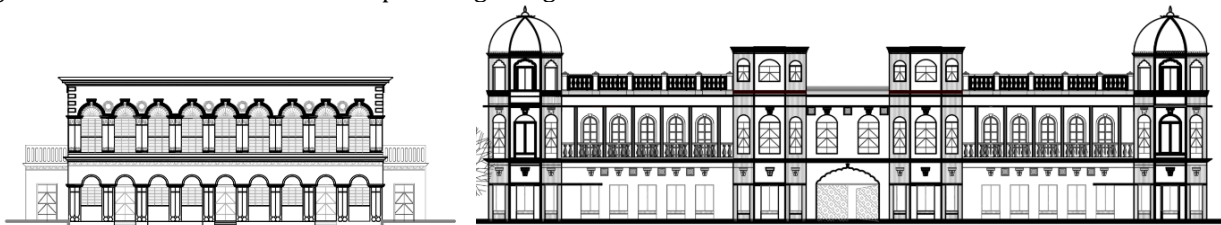
Figure 9. Andarmahal Elevation (left) and Kachari House Elevation (right) (Source: Author).

The area comprises a two-storied Andarmahal, a two-storied Kachari house where the accounts of plots and properties were calculated and preserved, a temple, a warehouse, a kitchen, and a mandap of worship. Besides, a small stable for cows and horses, cropland with three ponds, a vegetable garden, and paved pond-ghat have been planned in the region. The family crematorium has been placed on the bank of the pond. The Kachari house is a double-domed house at the entrance of the complex. It also served as an "Atithishala" or guest house during the colonial era. The inner house or Andarmahal encompasses arched openings with decoration, detailed wall ornamentation, and ornamented columns. During the war, the well-known lion gate was looted together with the expensive ornamental components on it.

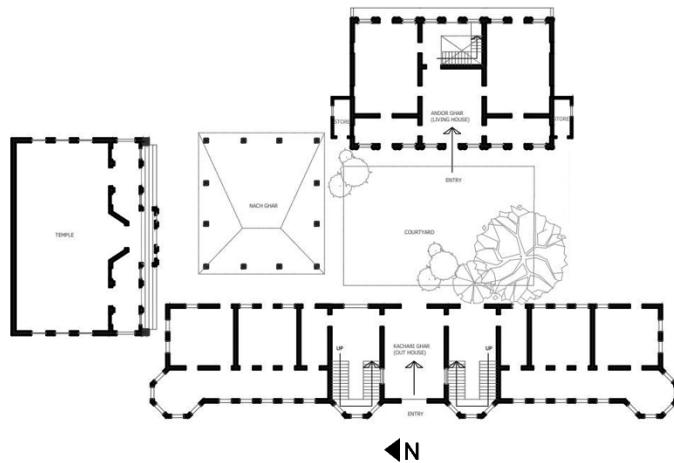
Figure 10. Ground Floor Plan of Andarmahal, Kachari House and Temple (Source: Author).

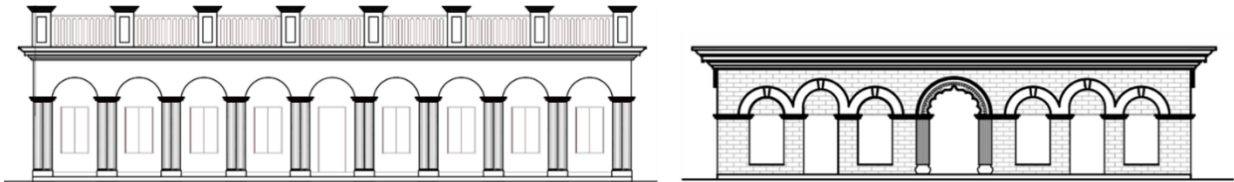
Figure 12. Andarmahal Elevation (left) and Kachari House Elevation (right) (Source: Author).

The main compound is situated on the west side of the entry road and an enormous pond called "Dhar Bari Dighi" is on the east. The compound consists of a public zone with gateways, a Kachari house or outhouse, a prayer area, Shiv Temple, and Radha-Madhav Temple, and a private zone covering Andarmahal or inner house, dance hall, kitchen, bathing zone, and two ponds. Built with brick and lime surki, the house displays grandeur columns, arched openings, and exquisite ornamentation. Varieties of plants including Jackfruit, Mango, Black Plum, Guava, etc. trees are present surrounding the house. City dwellers make expeditions around the region as part of their visit. During Durga puja and Doljatra, the family members and the Hindu community in the city take part in the celebration following the earlier rituals and traditions.

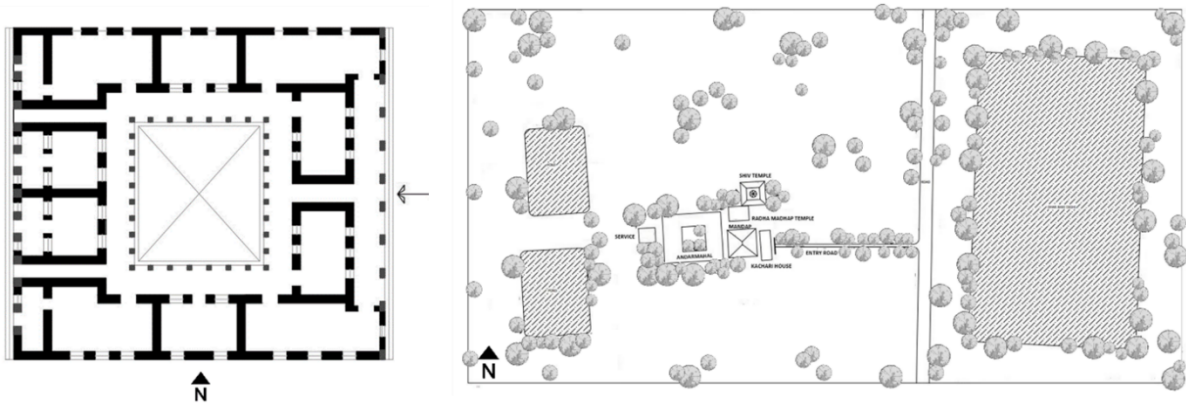
Figure 13. Ground Floor Plan of Andarmahal (left) and Original and Existing Roof Plan (right) (Source: Author).

Few articles have been published in the local newspapers regarding its conservation, but no official initiative has been taken to safeguard it as yet. The Kachari house is presently in a ruinous state and its ornamentations on the walls have faded. While chunks of plaster are falling off the plaster, heavy moss growth is weighing down the roofs of both the Andarmahal and Kachari house.

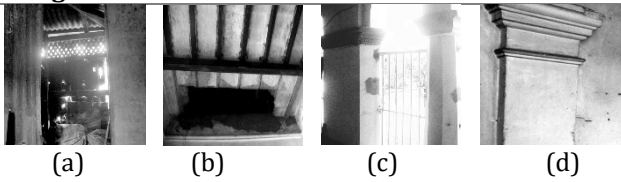
Name	Deformed/Damaged Parts	Images
Srimanta Paul Zamindar House	(a) Multiple rooms have dysfunctional doors, (b) certain areas on the roof have developed holes, (c) cracks emerged in the columns due to the addition of steel railings, and (d) a few pilasters are undergoing shape changes.

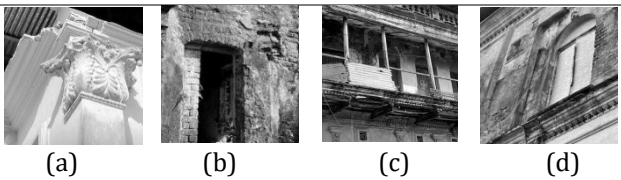
Satya Saha Zamindar House	(a) In certain sections of the temple and Kachari house, the cornices are deteriorating, (b) plaster has come off in some walls, (c) several railings have collapsed, and (d) a few casement windows have been damaged, and substituted with low-quality materials.
