Chapter 16

Transforming Historic Sites: the Alteration of Three Landmarks in Tripoli's Old City

* Aida M. Ejroushi

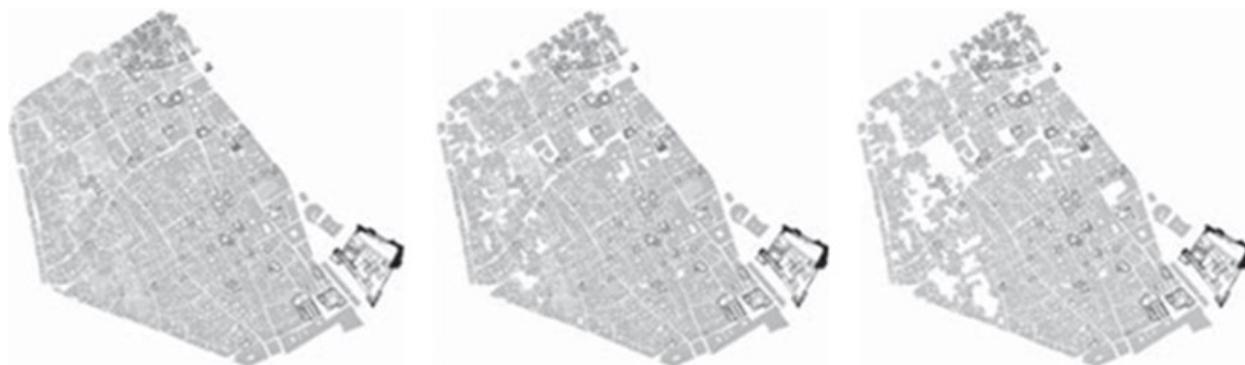
Figure 1. Plans of Tripoli's old city show the gradual extinction of the city's urban fabric and the appearance of empty spaces due to deterioration, neglect, and inappropriate interventions. Source: Micara (2014).

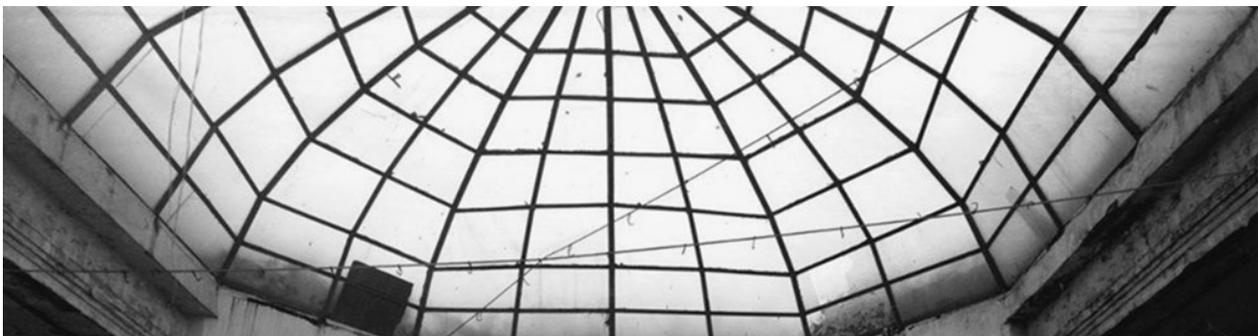
Figure 3. Marriotti Gallery's dome (cropped). Source: Pinterest (Accessed April 15, 2024).

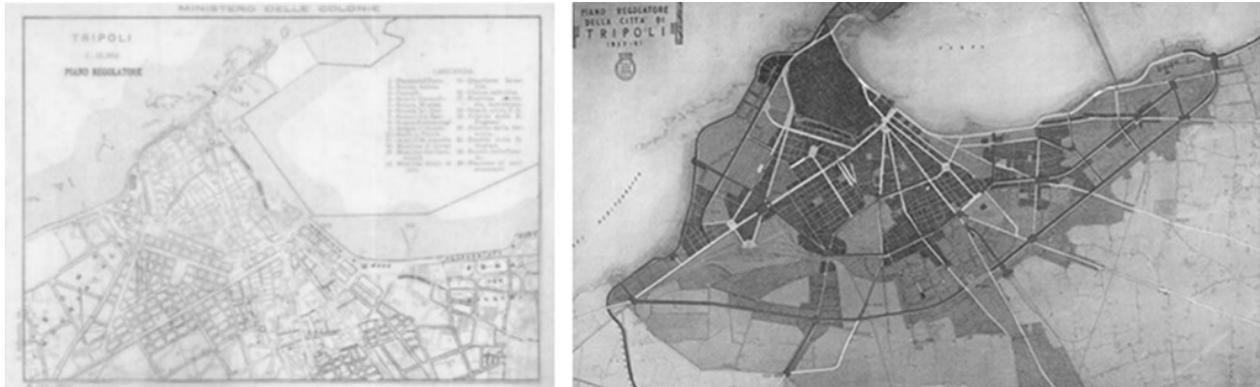
but, precisely, also those of expansion, to the south-west, envisaged by the Regulatory Plan” (p. 931). Figure 4, left, is Tripoli’s 1914 historic regulatory map, which does not show the gallery’s presence.

On the contrary, the gallery building is illustrated on the 1933 Italian regulatory map for developing Tripoli (Figure 4, right). However, the gallery could have been built between the 1920s and 1930s when several restoration projects took place within that area, including restoring the Red Castle, which entailed using ancient stones (Ejroushi, 2023). According to Aurigemma (1916), the Italians demolished part of the old city’s walls to use the stones for restoration.

Figure 4. Left–the 1914 regulatory map of Tripoli. Source: Public domain (Accessed April 15, 2024) from Wikimedia Commons. Right–the 1933 regulatory map of Tripoli. Source: Courtesy of the Libyan Department of Antiquities (DoA).

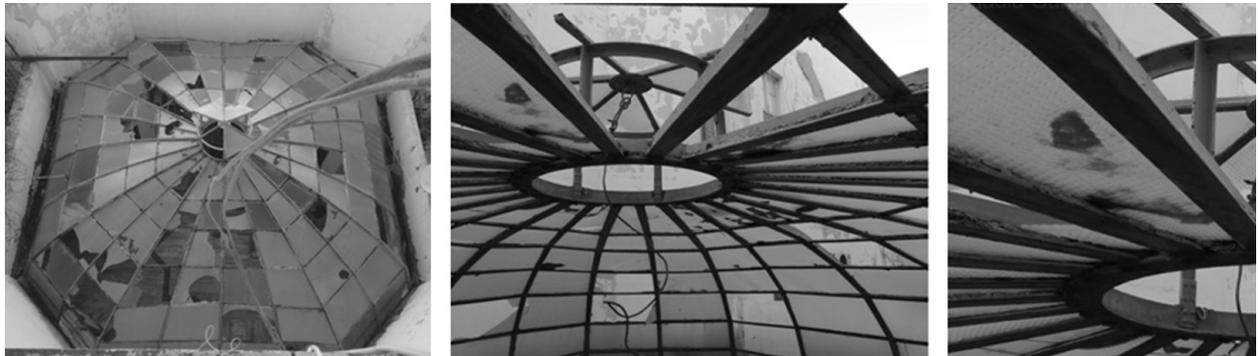
In June 2020, news about the work started on the Galleria Marriotti building’s dome was circulated. Decisions were made by the authorities of the OCTAB to demolish the old glass of the dome and replace it with colored sheets of plastic. Figure 5 shows the shape of the rough glass used to cover the dome and the proportion of its broken and intact pieces. Instead of repairing the dome’s metal structure, replacing the missing glass pieces, and softly cleaning its whole structure to maintain its originality and historic character, the Intact pieces were demolished and thrown away. The lack of specialized people in the administration agency led to the selection of an uninformed approach to dealing with the gallery’s historical materials.

Figure 5. The shape of Galleria Marrotti’s dome and the considerable amount of its intact rough glass before the 2020 interventions. Source: Photos uploaded by Hadia Gana (OCTAB’s board member and the creator of the idea to replace the dome’s glass with plastic sheets) to a Facebook post made by the author on June 13, 2020.

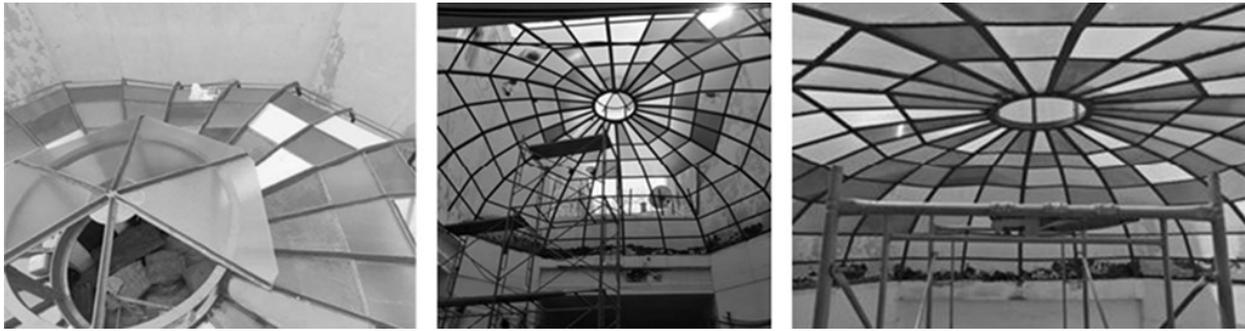
The shocking images of removing the historic glass and replacing it with sheets of colored plastic, a non-construction material, raised questions about the authorities’ awareness regarding the importance of safeguarding the historic character, material, and integrity of the old city’s historic evidence. This intervention also raises two criticisms. First, altering the original material of the dome with an irrelevant material was a violating action as it contradicts the Libyan preservation law and the international legislations that underscore the importance of protecting the original shape, materials, and historical character of cultural evidence. Second, using plastic, which is not a construction material, reflects a hasty and uninformed decision. Even though the plastic sheets adhered to the dome’s steel frame with a strong bonding material, they will likely twist, break, or detach from the frame due to the sun’s intense heat. Additionally, the plastic sheets may pose risks to people moving beneath them and could threaten the stability and durability of the dome’s structure itself. Today, the Galleria Marriotti’s dome speaks to the significantly inappropriate interventions that altered its historic shape, appearance, significance, and integrity. (Figure 6).

Figure 6. Left two Photos - the exterior and interior sides of Galleria Marriotti's dome during the process of adding colored plastic sheets. Source: OCTAB Facebook page (Accessed June 2020). Right-a photo of the interior side of the dome, uploaded by Hadia Gana to a Facebook post made by the author on June 13, 2020.

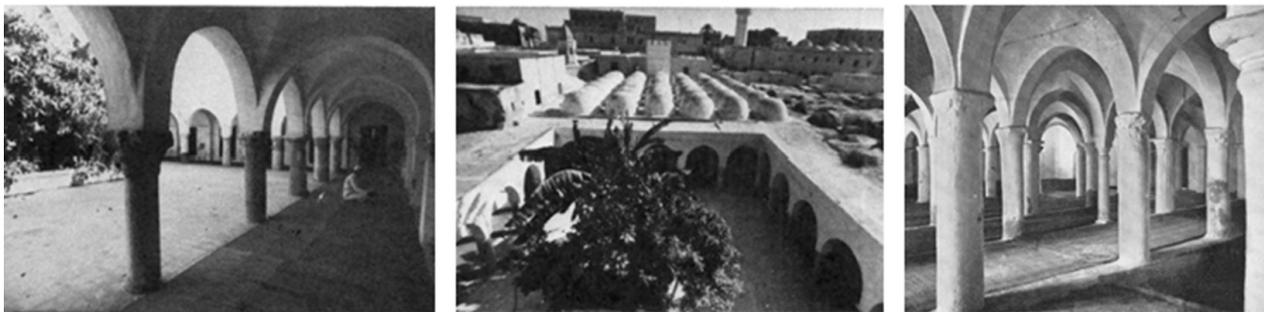
Figure 7. Left two images—a view through the Al Nakah Mosque's courtyard arcades and an overview overlooking the courtyard space and prayer hall's roof with 42 small domes (cropped). Right—an inner view of the prayer hall. Source: Shaglouf, et al. (1980, pp.42-43).

According to Shaglouf et al. (1980), the Al Nakah mosque's Madaa is located at the corner of the building on the southwestern side, overlooking the mosque's courtyard. They asserted that "the place of the Madaa is covered with a roof in the form of two parallel vaults supported by the outer wall of the building. The Madaa place can be reached through a long corridor next to the main door of the mosque" (p. 43). Figure 8 (left) shows the location of the Madaa space within Al Nakah Mosque. To the right is an undated image of the Madaa place's old shape before the 2021 interventions. Al Nakah mosque's original Madaa included a series of closely spaced small stone bowls carved in a stone base and spread along the Madaa space's northwestern wall. A domestic water well stands on the southwestern side close to the corner. These pieces of cultural evidence explain how old Muslims who inhabited the old city used to apply Wudu using a unique water-saving technique. It could be inferred that water saving was considered when the size of the stone bowls was decided and that the bowls were likely sufficient for each individual to apply Wudu.

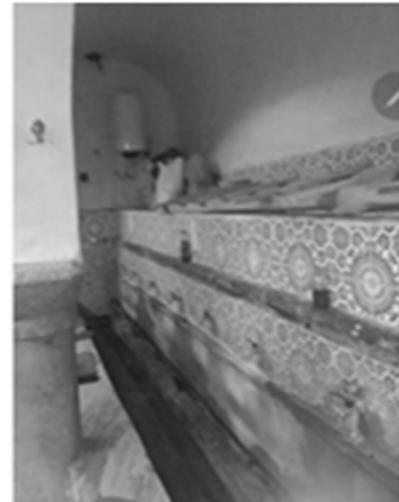
However, the image (to the right) reveals that a rectangular structure covered the original Madaa's stone bowls at an unknown date. The facing side of the structure was utilized to add a series of water taps and a shelf for soap and cleaning liquids. The distance between the water taps and the room's wall represents the location of the old Madaa. Limited information was found about whether the inside part of the rectangular structure was a hollow space or a solid mass. However, it is more likely that building such an immense structure around the original Madaa reflects considerable attention to hiding them as an outdated Wudu technique while creating a modern Wudu technique using water taps. To conveniently help those praying to wash their body parts, a raised block used as a

seat was attached by a rectangular lowered duct where those praying could also wash their feet. Ceramic tiles covered the rectangular structure's vertical and horizontal sides.

Figure 8. Left—the location of Al Nakah mosque's Midaa place (source: Shaglouf et al. (1980, p. 39). Right—the built structure above the old Midaa, added between an unknown year and 2021. Source: Courtesy of Ms. MS.

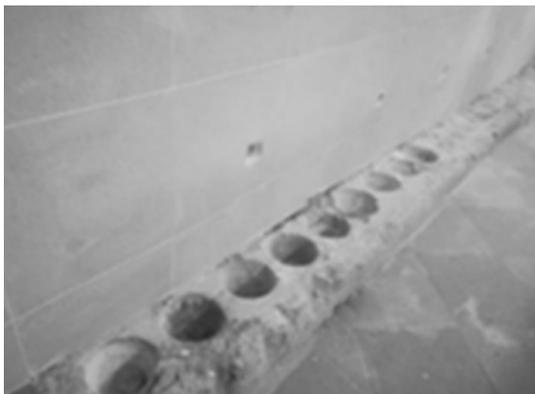
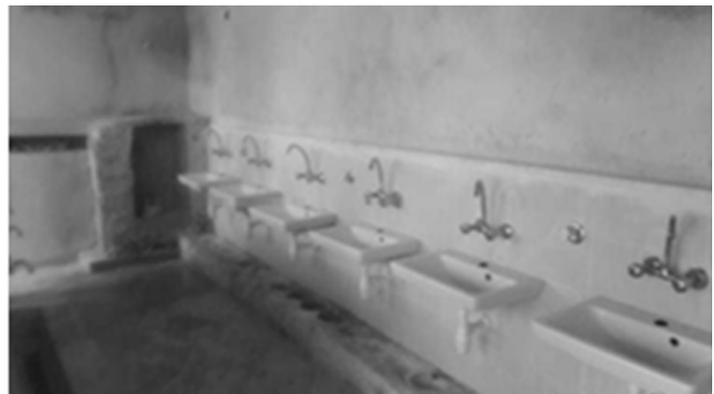
Around April 2021, news spread about the applied renovations in Al Nakah mosque on the old city administration's official Facebook page. The images showed alterations applied to the shape and materials of the mosque's Midaa place. By comparing the before and after images, it can be inferred that the rectangular structure was removed, revealing the original location of the original Midaa, represented in the small stony bowls. There is limited information about whether the stone base in which the bowls were carved was the original floor level of the Midaa space. Unfortunately, the applied interventions altered the previous water taps rather than preserving the original Midaa. The images show that most of the stone bowls were affected, and their details were either faded, demolished, or obliterated. The remaining number of small stone bowls is comparably small, as many have been affected by the added changes. In addition, above the historic stone bowls, a series of modern white sinks were built, and modern tiles covered the wall between the bowls and the new sinks.

Moreover, the original floor of the Midaa place was altered with new modern tiles. Today, Al Nakah mosque's unique historic Midaa space speaks to the inappropriate approach to restoring such an ancient technique and building. It also reflects shortages in prioritizing preserving historic evidence over renovating historic landmarks (Figure 9).

Figure 9. Al Nakah Mosque's falsified shape of Midaa and the added modern sinks on top of the stone bowls. Source: OCTAB's Facebook page (Accessed April 9, 2021).

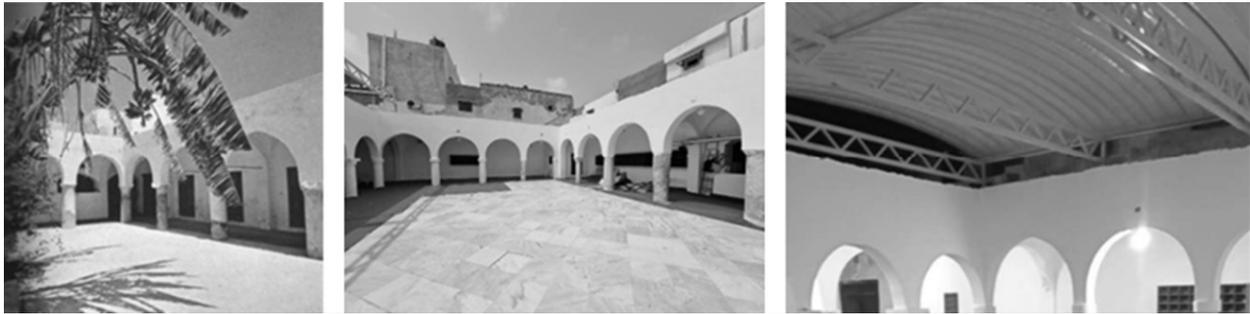
Instead, they were neglected and lost their historical significance for the interest of adding modern sinks. In such an iconic historic building, alterations should be limited while preserving the mosque's historic character, which is the priority. Figure 10 includes images of the original shape of the courtyard space before the intervention and the floor tiles that were replaced, and the roof elements added after the intervention.

Figure 10. Left two images—the Al Nahah mosque before the 2021 interventions. Source: Ms. MS. Right—the mosque after the applied interventions. Source: Al Nahah mosque's Facebook page (Accessed April 2024).

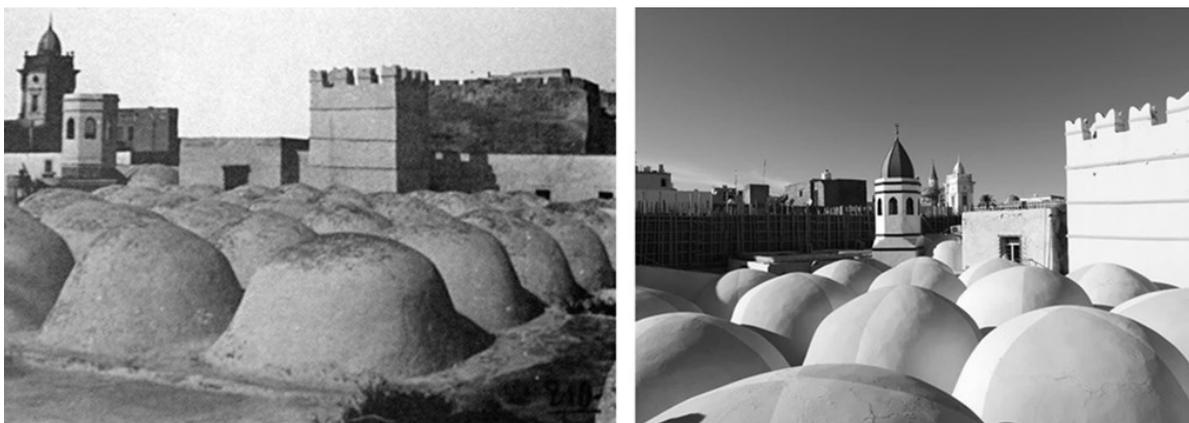
The other alterations to the Al Nahah mosque changed the shape and material of its exterior elements: the domes, minaret, and facades. Layers of cement plastering were used mainly to give the domes regular semi-spherical shapes rather than maintaining their original forms. Moreover, a color paint pattern was applied on each dome using light yellow and light orange colors (Figure 11). These inappropriate interventions disfigured the domes' original shape and eradicated their historic character. The mosque's minaret and facades were treated similarly and painted using modern and shiny colors. Figure 12 shows Google Earth captures for the Al Nahah mosque before (2011) and after (2023), and the added changes to its original components and their altered functions. Today, the outer and inner spaces of Al Nahah mosque embody the awkward approach of restoring Tripoli's old city and its irreplaceable components.

Figure 11. Left—the Al Nahah mosque's original roof domes. Source: Shaglouf, et al. (1980, p. 41). Right—the applied changes to the mosque's roof domes. Source: OCTAB's Facebook page (Accessed October 17, 2020).

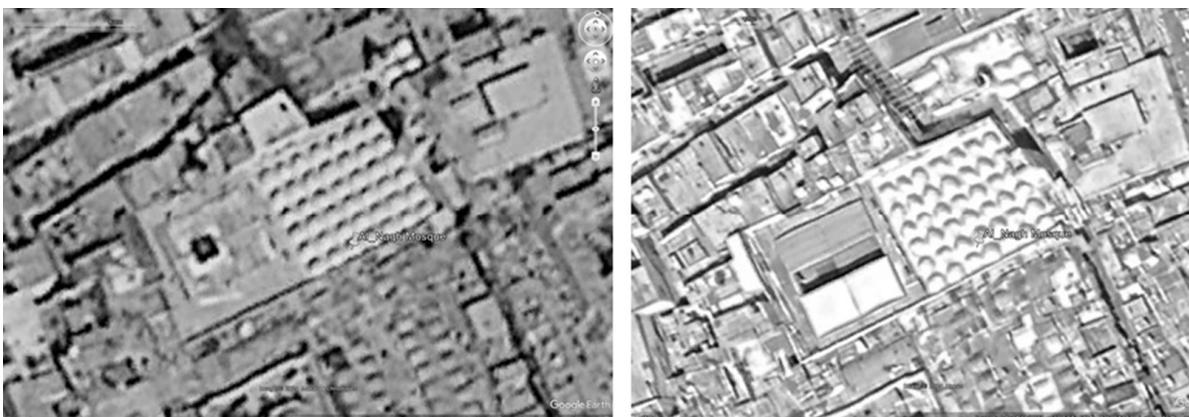
Figure 12. Left— Al Nahah mosque's courtyard before adding the canopy roof. Right—the roof after (2023). Source of images: Google Earth (Captured on April 18, 2024).

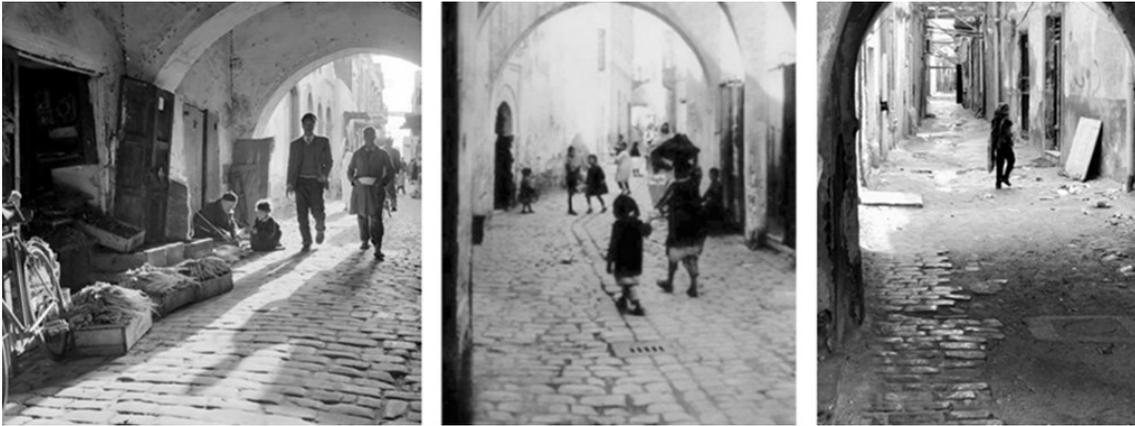
Figure 13. Left—long-lasting pavement style of Tripoli's old city streets with an interlocked straight pattern. Middle—informed approach using a narrow line for installing sewage and water systems, minimizing damage to the existing pavement. Right—uninformed approach caused significant damage to large sections of the original pavement. Source: Courtesy of Mr. Nasser Gurgi.

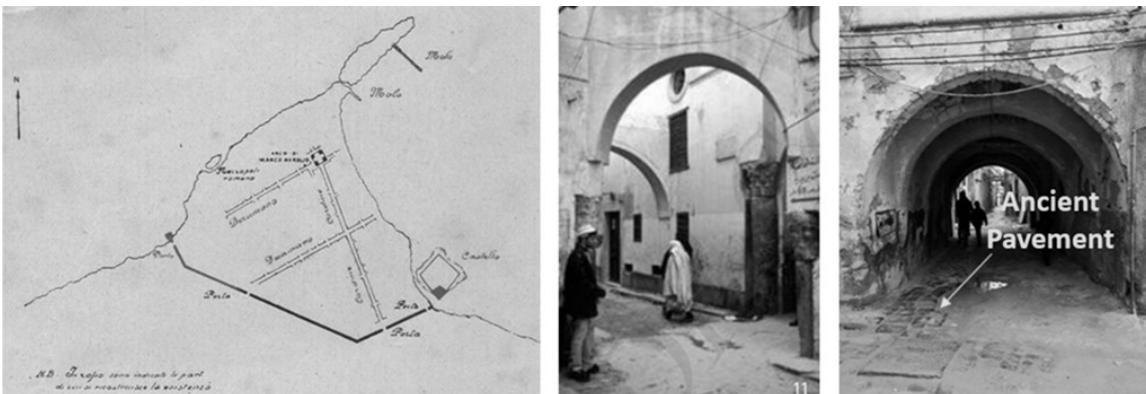
Typically, the urban planning of Roman cities is characterized by the presence of a street network that includes an intersection of two main streets, *Cardo Street* and *Decumanus Street*, under an arch of triumph. From this intersection, other streets and alleys branch out and are arranged. Similarly, these primary components exist in Tripoli's old city due to the Roman occupation that lasted from the second century BC to the seventh century AD. However, Tripoli has two *Decumanus Streets*, resulting in two main intersections with *Cardo Street* (Figure 14). The main street intersection starts under the *Marcus Aurelius Arch of Triumph*, located on the northeastern side of the old city, and represents the primary approach to the city from the sea. The second intersection is at the midway point of *Cardo Street*. It is called (in Arabic) '*Al Arbaa Arsat*,' which means "the four columns" due to inserting four different, in shape and size, Roman columns (with Corinthian capitals) at the corners of the intersection's four buildings. Despite many spots of the Roman streets' pavement having faded or erased over time due to erosion and lack of preservation efforts, the remaining evidence conveys considerable information about these ancient streets' paving patterns and material.

Figure 14. Left—Tripoli's ancient city and the Roman Street Network. Source: Aurigemma (1916, p. 300). Middle—the '*Al Arbaa Arsat*' intersection between *Cardo Street* and the second *Decumanus Street*. Source: Micara (2014). Right—the remaining evidence of Roman streets pavement in one of Tripoli's old city streets. Source: Courtesy of Mr. Nasser Gurgi.

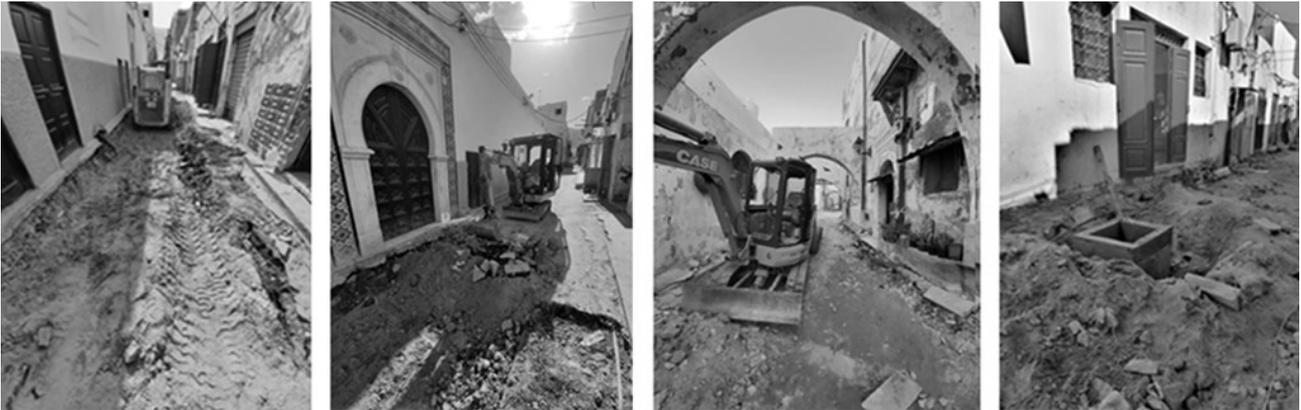
Instead of using manual digging techniques with limited excavation widths along the city's historic streets to avoid affecting the fragile buildings on both sides, bulldozers, caterpillars, and other motorized digging machines were employed, resulting in strong vibrations and ground disturbance. Moreover, the excavations extended from edge to edge of the streets, causing damage to old buildings that lack supporting structures and threaten their stability and cohesion (Figure 15).

Figure 15. Bulldozers were used to remove the historic street pavement of Tripoli's old city and dig the ground for water and sewage system maintenance. Source: OCTAB's Facebook page (Accessed August 2023).

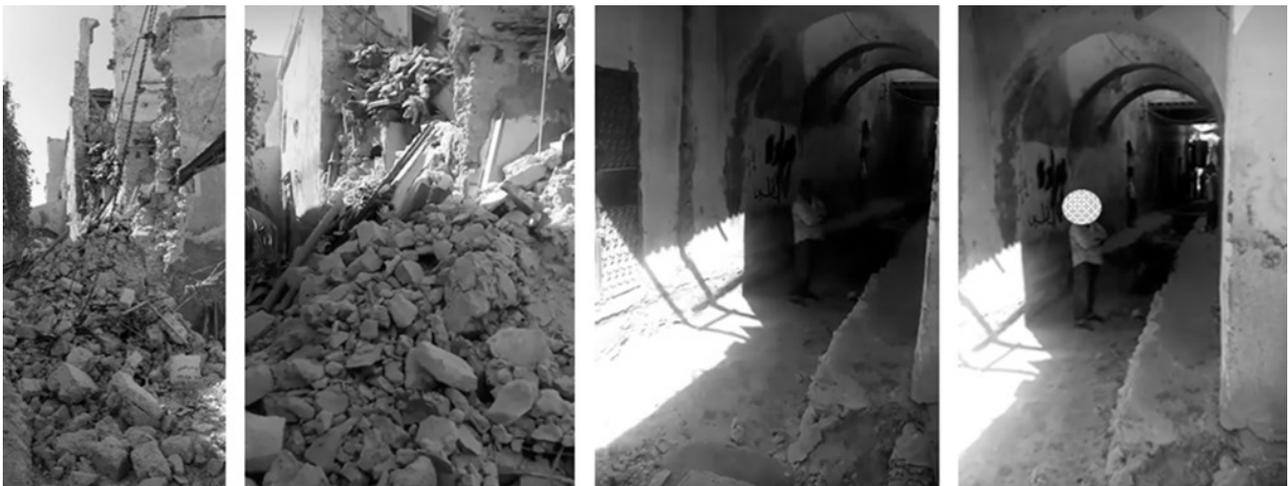
The adopted uninformed approach by the OCTAB to prepare for underground and pavement projects has caused significant damage to the city's components and raised a public debate. Complaints from the old city's residents revealed the scary and intense sounds and heavy vibrations caused by the excavation works throughout the city's tiny alleys and fragile buildings. Moreover, in August 2023, one of the old city's historic buildings, on Kosha Al Soffar Street, completely collapsed due to the intensity of excavation. The images in Figure 16 show the narrow width of the alley per the size of the created excavation's depth and width. Not only did the forceful digging, excessive depth, and extended width of the excavation on the alley's two sides lead to the collapse of the building, but they, no doubt, disturbed the cohesion of the other buildings, either attached or close by.

Figure 16. The collapsed building on Kosha Al Soffar Street in Tripoli's old city. The collapse was due to excavation works. Source: Facebook pages: Save the Old City and Tik (Accessed July 2023).

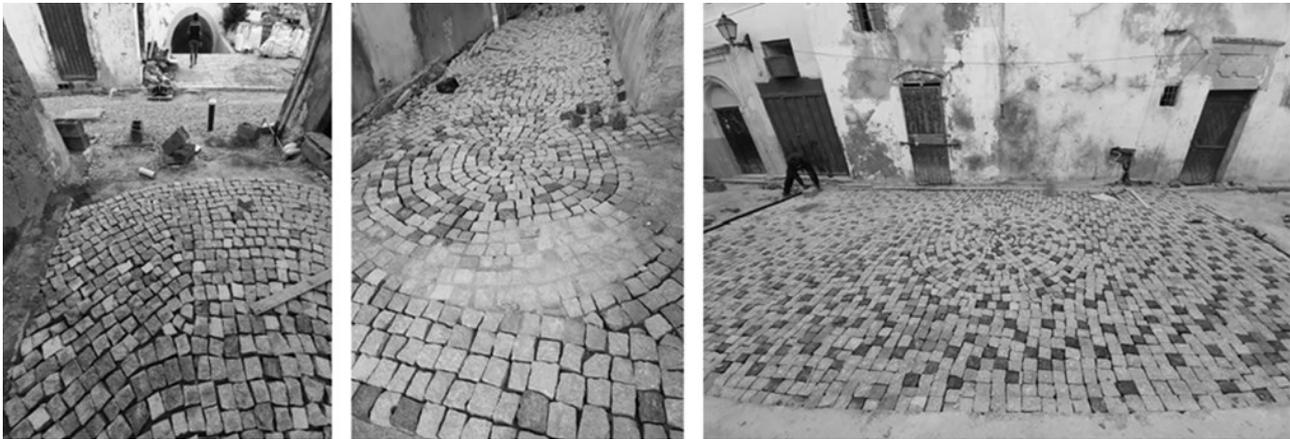
More significantly, the original linear pattern style of pavement was altered by a chaotic circular pattern (Figure 17). The rectangular stone tiles were replaced by a mix of sharp cubical and rectangular granite stones (cobblestone) of three colors (light gray, dark grey, and light brown). In addition, the new paving stones were installed randomly by unskilled workers in irregular circular shapes, resulting in chaotic shapes. The new paving pattern style reflects its irrelevance to the old city's original and long-lasting pattern. Moreover, the circular paving pattern has affected the serene atmosphere of the old city's alleys and the safety of pedestrians on it.

The original linear arrangement of the city's street pavement was installed in an interconnected pattern, which connected and secured each stone tile to unify them into a cohesive whole. This approach ensured that the entire structure functioned as a unified, interlocked system, maintaining the integrity and durability of the street. In contrast, the sharp squared and rectangular cobblestone units introduced in the recent project are not interlocked or tied together. This lack of integration prevents the stones from acting as a single structural component, leaving them separated and unstable. The unassembled new pavement can pose significant risks to the safety of pedestrians and the tires of bicycles and carts. The inconsistent surface and lack of cohesion can lead to potential hazards such as tripping, slipping, or damage to any moving object passing through the area. Today, Tripoli's old city has lost the remaining evidence of its long-lasting ancient pavement materials, and the resulting chaotic circular shapes reveal a severe shortage of specialists and a lack of commitment to historic preservation legislation.

Figure 17. The imposed circular pavement pattern style using cobblestone and the arbitrary distribution of stone units over the old city's streets and alleys. Source: OCTAB Facebook page (Accessed February 1, 2020).

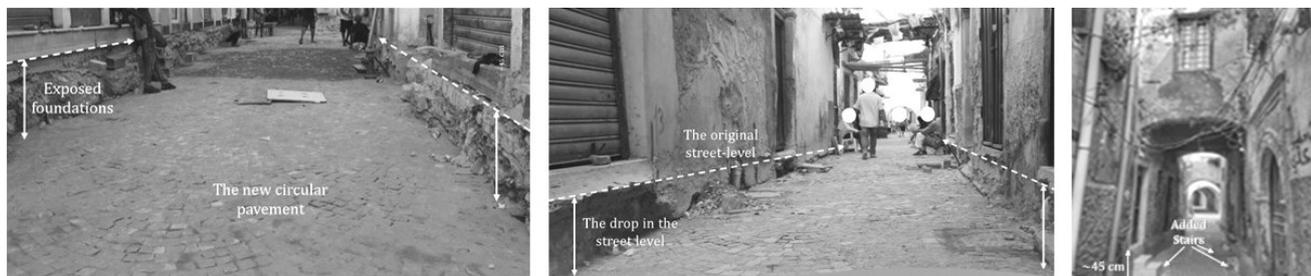
The project caused substantial changes in the street elevation, creating a disparity between the building's entrances and the street level. These changes led to adding obstructive steps to facilitate access to the buildings' doors, further exacerbating accessibility shortages for individuals with disabilities within the area. Such an intervention suggests a lack of careful planning and attention to the existing heights of the buildings' entrances. Figure 18 illustrates the significant differences in elevation between the street level and the buildings' entrance levels that the OCTAB's inappropriate interventions have caused. This deformation could have been avoided through proper design and planning during the project's initial stages before implementation.

Figure 18. The differences in street elevation and buildings' doors created due to a lack of informed street paving practices. Source of left two images: OCTAB Facebook page (Accessed September 2021). Source of right image: Zawaia Trablusia Facebook page (Accessed May 2024).

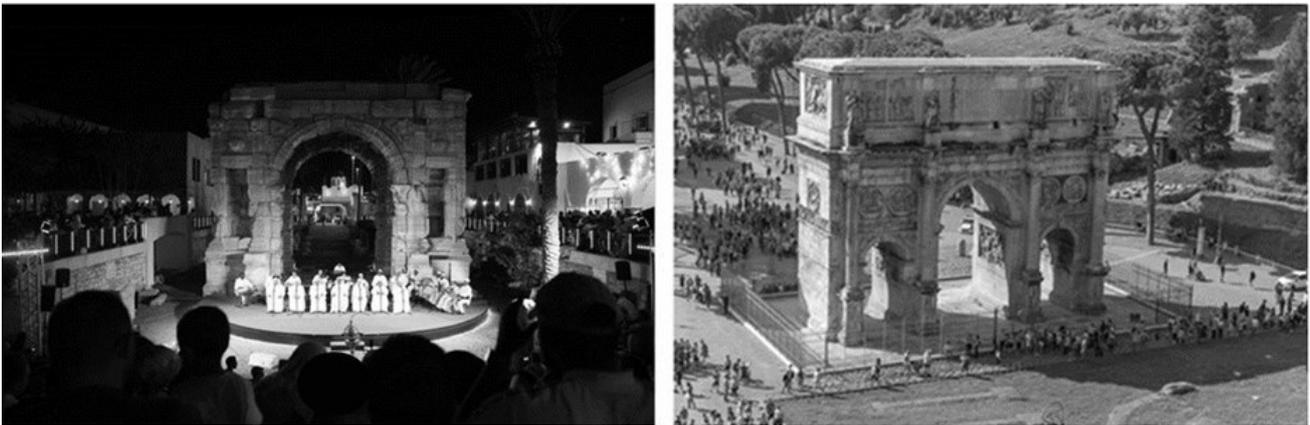
In the time since Shghaiwi’s research was conducted, the OCTAB has continued to exceed the limits of their authority, most recently having trespassed on the boundaries of the triumphal arch in 2023 by constructing a small amphitheater nearby and permitting concerts to be held just beneath the arch despite its fragility. These actions further demonstrate a disregard for the significance of Libya’s cultural heritage, considering how such monuments are preserved in other places (Figure 19).

Figure 19. Left–Triumphal Arch of Marcus Aurelius in Tripoli after OCTAB’s 2023 interventions. Source: Medina’s Nights Facebook page (accessed July 13, 2024). Right–Triumphal Arch of Constantine in Ancient Rome. Source: Stefano Montesi/Corbis via Getty Images (cropped), ThoughtCo (accessed May 5, 2024).
