## Chapter 19

# Preservation of Abandoned Rural Settlements Through Re-Functionalization: The Case of the Ancient City of Side

\* Aysel Özge Kocabaş, Tuçenur Erbilgin, Azra Turgut, Fatma Seda Çardak

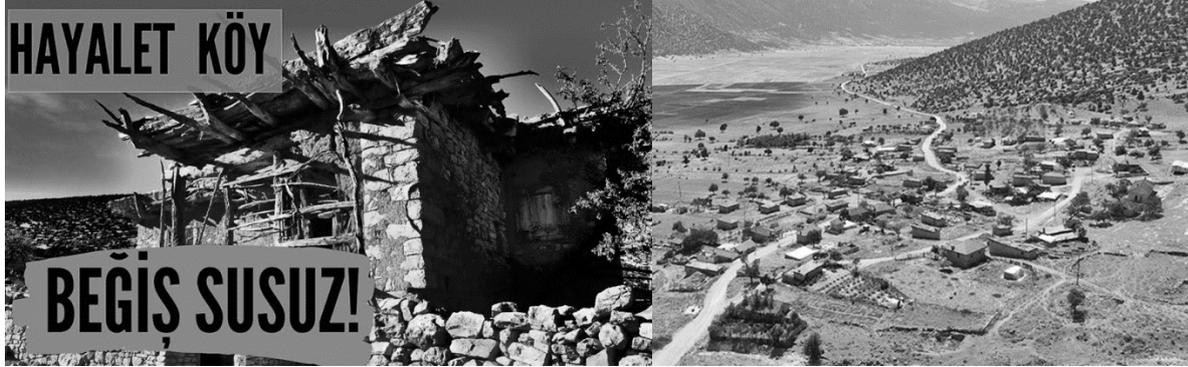
**Figure 6.** Traditional texture of Beğiş Village (Yaman,2019)

The village of Beğiş in Antalya has largely lost its population over time due to economic and cultural reasons. The masonry buildings with wooden floors that make up the traditional texture of the village have deteriorated due to the effect of abandonment (Figure 6). In 2012, with the idea of "Life Village", some of the buildings were purchased and the necessary interventions were made for reuse. Within the scope of this project, infrastructure foundations were established, traditional houses were repaired, and the village was reopened for use with a tourism approach with various social and cultural activities (Figure 7) (Güler, 2019).

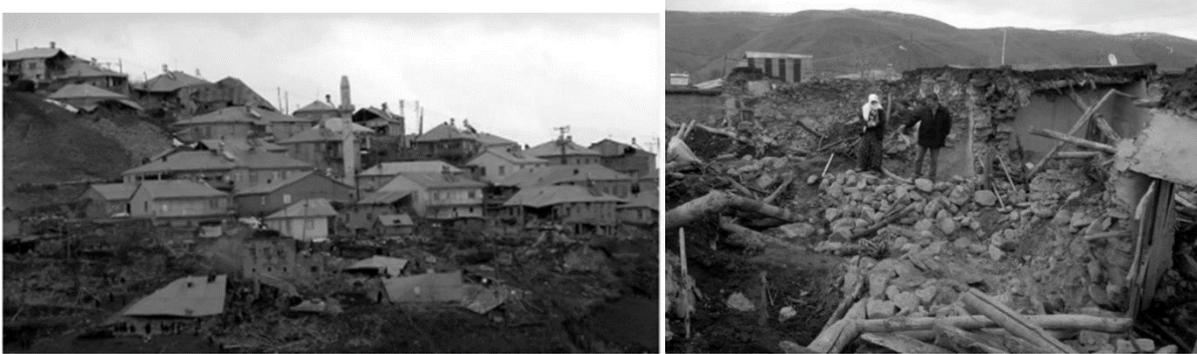
2010, a moderate earthquake occurred in Kovancılar district of Elazığ, killing 42 people and destroying many houses in the villages. The settlement that suffered the greatest loss of life and property in the Kovancılar earthquake was Okçular Village (Figure 19). In the examinations made by experts in Okçular Village, they attribute the high damage of the settlement in the earthquake to the use of poor quality materials in traditional structures built with mudbrick and stone materials (Figure18) (Sunkar , 2011).

**Figure 18.** The traditional texture of Okçular Village (Sunkar ,2011).  
**Figure 19.** Post-earthquake situation of Okçular Village (Sunkar ,2011).

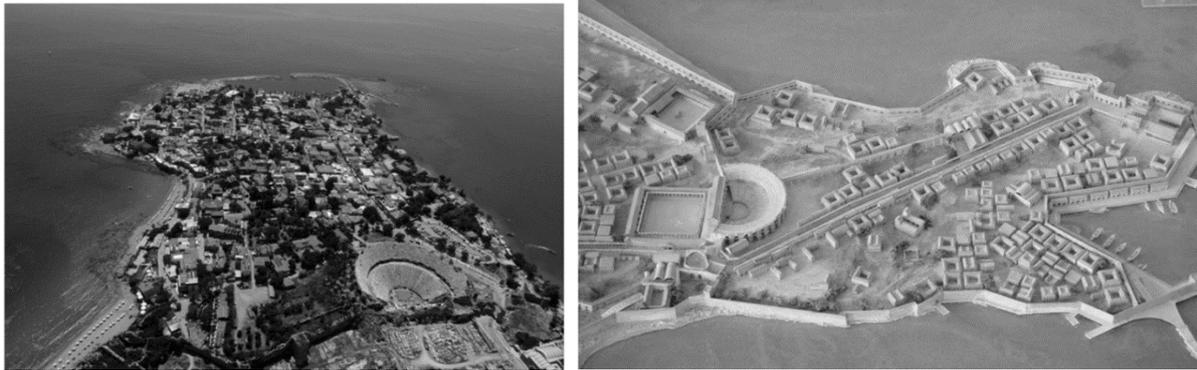
**Figure 28.** Side Ancient City general view

The plan of the city is a continuation of the previous settlement. The settlement was established before the Neolithic and pre-Caelotic periods. The period with the most dominant traces is the Hellenistic period. The Hellenes migrated after the Anatolian civilizations. Hellenes fused with Anatolian civilization. It is thought to represent the Anatolian tradition that Athena, who chose this city with the demonstration of the Roman period city foundation mythology Appolon, carried a shield and pomegranate, a symbol of fertility. Archaic and Classical Period VI century BC. the whole region came under the rule of the Lydian kingdom and then the Persians. In 334 BC, it opened its doors to Alexander the Great without any objection. The city has been a subject of constant debate by the Hellenic kings. Jews continued to exist in Side during the Hellenistic Period (Figure 28-29).

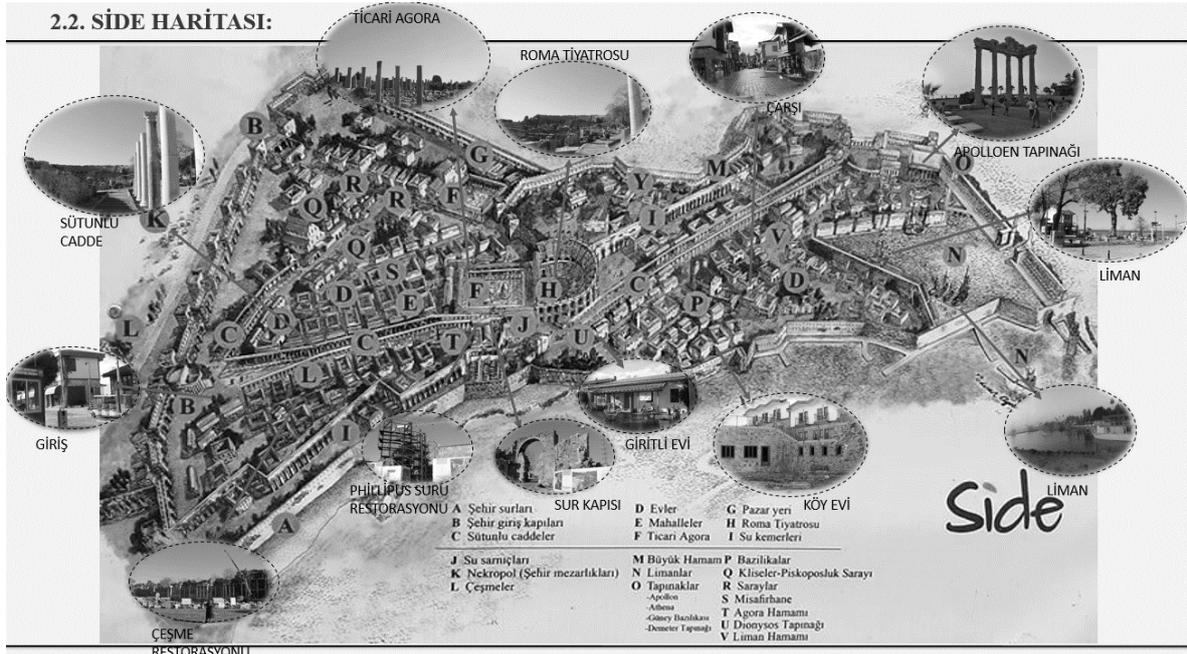
Since the city was abandoned after the crusades, the buildings suffered a great devastation. Many buildings were destroyed and remained under the ground. In 1924, Cretan immigrants came to the region. Selimiye village with 68 households was established. Uniform houses were built and during the construction of these houses, marbles and stones from the surrounding historical monuments were used. It is said that Italian minorities used the area as a quarry and ruined historical monuments. The immigrants who came here scared them away. At first, immigrants were engaged in agriculture and olive cultivation. In the 70s, tourism started to become active (Kaderli, 2009). In the 80s, the Ministry of Conservation and Tourism started to carry out conservation and restoration works in this region. Later, with the support of the state, the state carried out restoration works together with the people. The ancient city and the newly established Cretan village were turned into a tourism city together (Figure 32)(ÇŞİB).

**Figure 32.** Plan of the ancient city of Side and photographs of the current situation (edited by the author with reference to the Rehbername, 2024).

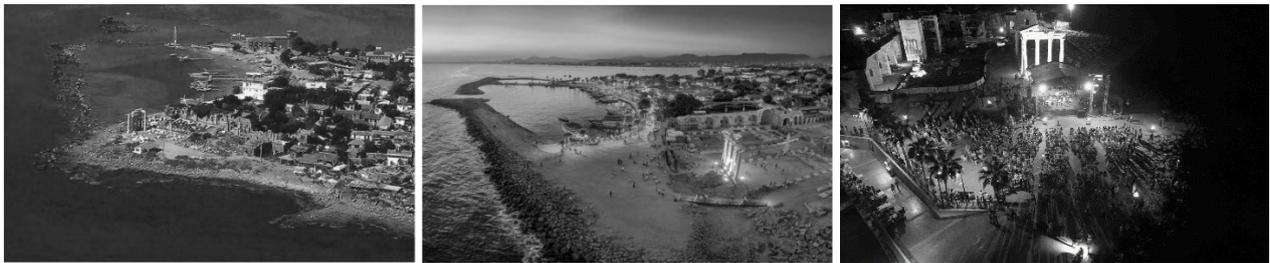
All the known and unearthed temples belong to the Roman period. Mansel and his team started the first excavations in 1947. The temple excavations started again in 1962 and new remains were found. Mansel says that there was a square and temples surrounded it. Among the restored temples, only the Temple of Apollo was uncovered (Şener, 2022). There are 5 temples: Apollo, Athena, South Basilica, Temple of Dionos, Temple of Man. The remains of the temples were uncovered over time. The restoration of the Temple of Apollo was carried out by Zeynep Ahunbay under the leadership of Jale Inan between 1977 and 1991. The ruins of the temple were uncovered over time and revitalized together with the harbor. It was illuminated and landscaped for tourism. The area was illuminated and re-functionalized for concerts and festivals (Figure 33) (ÇŞİB)

**Figure 33.** Apollo temple change (ÇŞİB, Neredekal,2024) (Hurses,2023)

| STRUCTURE | PERIOD | RE-FUNCTIONALIZATION | APPLICATION | POSITIVE SIDE | NEGATIVE SIDE |
|---|---|--|---|--|--|
| Temple | Roman Period | Open Air Exhibition Space, Concert Area | Exposure and consolidation of archaeological excavation | Maintenance, Repair, By Consolidation Structure Preserved And Revealed | Use as a Concert Venue History Due to Sound and Light Damaging Residues |

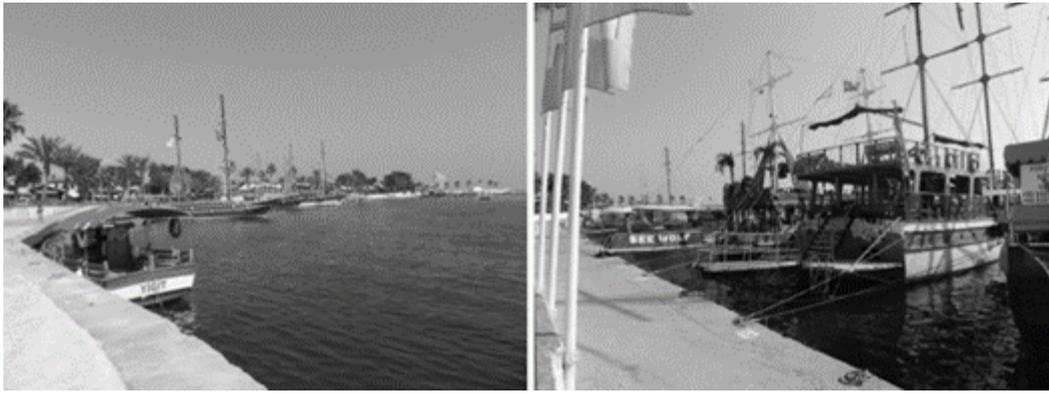
It is planned to revive the important ancient harbor used for trade purposes in the Roman and Hellenistic period and transform it into a marina (Figure 34-35) (Çubuk, 2013).

Figure 34, 35. Side Ancient City Ancient harbor today (Çubuk,2013)

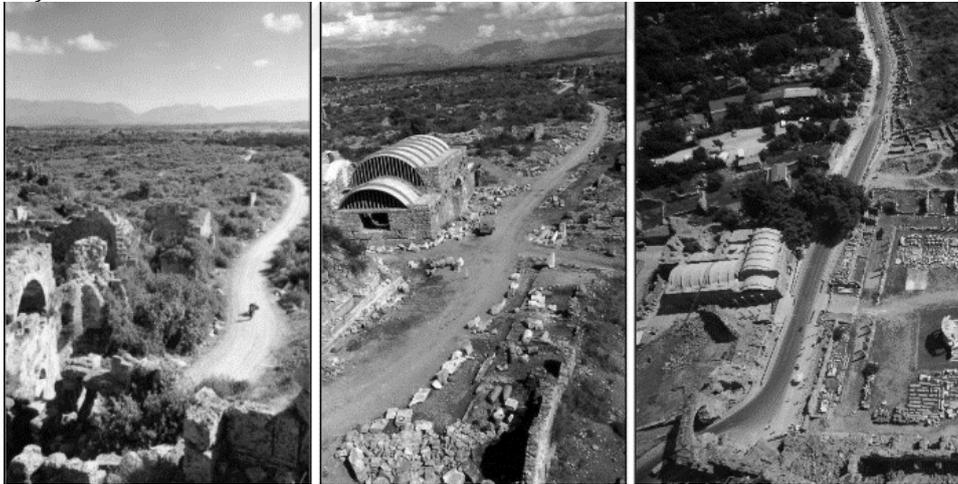
They were unearthed by excavations between 1947- 49 and 1959- 60 (ÇŞİB). They belong to the Roman and Hellenistic periods. The street was unearthed from the main gate towards the modern settlement. The arch is located at the point where the street starts to slope. The street was later paved with stones and arranged in such a way that vehicles could pass. The arch is preserved and restoration works are still ongoing around it (Figure 36-37) (Atalay, 2016).

Figure 36 a. Photograph of the colonnaded street (C Street) in the 1950s, 1960s and 2015 (Atalay, 2016)

| STRUCTURE | PERIOD | RE-FUNCTIONALIZATION | APPLICATION | POSITIVE SIDE | NEGATIVE SIDE |
|---|---|--|---|--|--|
| Avenue C (colonnaded street) | Hellenistic Period | Touristic-cultural route Open-air exhibition space | Archaeological excavations Excavation and Exhibition. | Creating a cultural route For visitors to the area Creating convenience | Archaeological exhibits in the Open Damage to artifacts for different reasons Seeing |

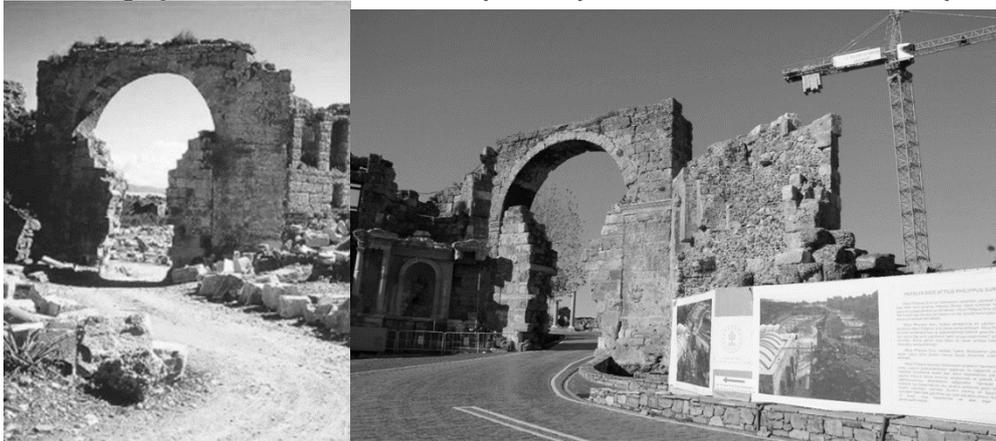
Figure 36 b. Pre-functionalization Tak (ÇŞİB)

Figure 37. Tak's outlook for 2024 (Author, 2024)

| STRUCTURE | PERIOD | RE-FUNCTIONALIZATION | APPLICATION | POSITIVE SIDE | NEGATIVE SIDE |
|---|---|--|---|--|--|
| Tak | Roman Period | Open Air Exhibition Area | Consolidation | Conservation Practices Transmission to Future Generations Thanks to | Six of them are open to vehicular traffic. Vehicles Damage the Taka. |

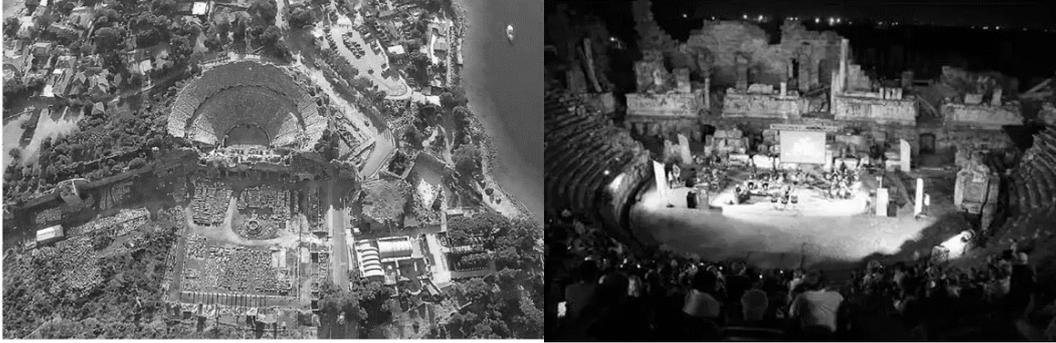
It is thought that the building belongs to the Hellenistic or Roman period and there is no clear information supporting this. Theater repairs were started in 1971 without a survey. Then it was stopped and continued by drawing a survey. In 1982, the project was started by the Ministry of Culture and Tourism by integrating it with the surrounding area. It lasted between 1982 and 2008. The demolished blocks of the stage building of the orchestra

were stacked in a corner of the theater. Architectural measurement, drawing, analysis and restitution studies were carried out. Excavation, cleaning and repair works were carried out and the building reached its present position. The theater was later functionalized and turned into a concert area (Figure 38-39) (Kaderlı, 2009).

**Figure 38.** Bird's eye view of the ancient theater (ÇŞİB)

**Figure 39.** Functionalization of the ancient theater as a concert venue ( Milliyet, 2018)

| STRUCTURE | PERIOD | RE-FUNCTIONALIZATION | APPLICATION | POSITIVE SIDE | NEGATIVE SIDE |
|---|---|--|---|--|--|
| Theater | Rome and Hellenistic Period | Tourism and Cultural Visit Area, Concert Area | Excavation, Cleaning and Repair. | Cultural Thanks to Events Making the Area More Attractive | Use as a concert venue Historical due to sound and light damages residues |

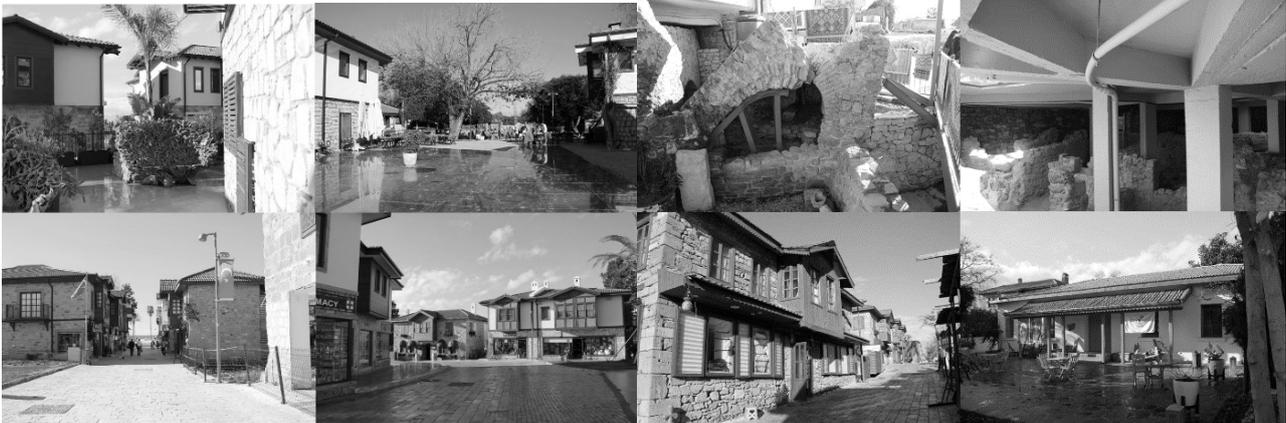
After Side was abandoned, Cretan immigrants came to the city in 1924 and established the village of Selimiye on top of the old ancient city. Restoration works are still ongoing in Side, where houses built in the tradition of ancient and Ottoman architecture are intertwined (Figure 40). In 2014, the Side Ancient City Conservation Revision Zoning Plan was approved by the Antalya Conservation Regional Board and the Ministry of Culture and Tourism and entered into force. Buildings that did not belong in the traditional housing texture were demolished. While the historical buildings were repaired, the buildings above the ground and the remains of the historical archaeological excavations below the soil level, the colonnaded street and old buildings were unearthed. Archaeological remains were examined together with experts and their preservation and repair were carried out (Figure 43) (ÇŞİB). Most of them were monitored under the glass floor (Figure 41). Urban design and pedestrianization works were carried out in 2 stages in the historical peninsula, improving the quality of public spaces and making access to these areas safer. In addition to these, in order to preservation and ensure the continuity of the Cretan culture, the old school building in the area was functionalized as the Cretan Culture House - Cretan Museum (Figure 47). Again, it was aimed to preserve the traces of daily life by opening a Cretan Coffee House in the square (Figure 44-45-46). The implementation of approximately 30 percent of the parcels within the planning area of the Ancient City of Side has been completed; work is ongoing.

**Figure 40.** Restored houses in Selimiye Village (Author, 2024)

**Figure 41.** Selimiye village glass lantern application (Yazar, 2024)

| STRUCTURE | PERIOD | RE-FUNCTIONALIZATION | APPLICATION | POSITIVE SIDE | NEGATIVE SIDE |
|---|---|--|---|--|--|
| Giritli houses | 1924 Ottoman | House, shop, cafe | Above ground restoration Underneath The sections were covered with glass and exhibited. | Different period suffixes and tried to preserve them. | The part covered with glass can be damaged then there has been dampness and moisture in some glazed places has caused vegetation. It damages the historical remains. |
